Naval Surface Warfare Center Carderock Division

NSWCCD-50-TR-2003/029 Aug 2003

Technical Report

Propeller Inflow Measurements on an Air Cushion Landing Craft Vehicle (LCAC)

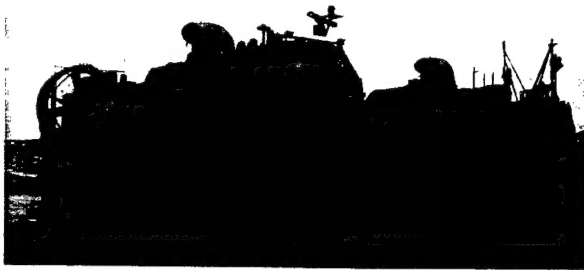
Figure 1 LCAC test vehicle

Measurements were made at 25, 35, and 45 knots going both upwind and downwind on a ESE-WNW track in St. Andrews bay, adjacent to Panama City, FL. The test was done on LCAC hull number 66 carrying an M60 tank as payload in the center of the craft. Figure 1 shows an overview of the craft and Figure 2 shows the tank. Table 1 summarizes the vehicle and environmental conditions, including weather data from the hourly records of Tyndall Air Force Base located adjacent to St. Andrews Bay.
